Summary of Columbia Lake Stewardship Society's 2022-23 Water Quantity Monitoring Program

Prepared by W. Thompson, M.Sc.

January 2024

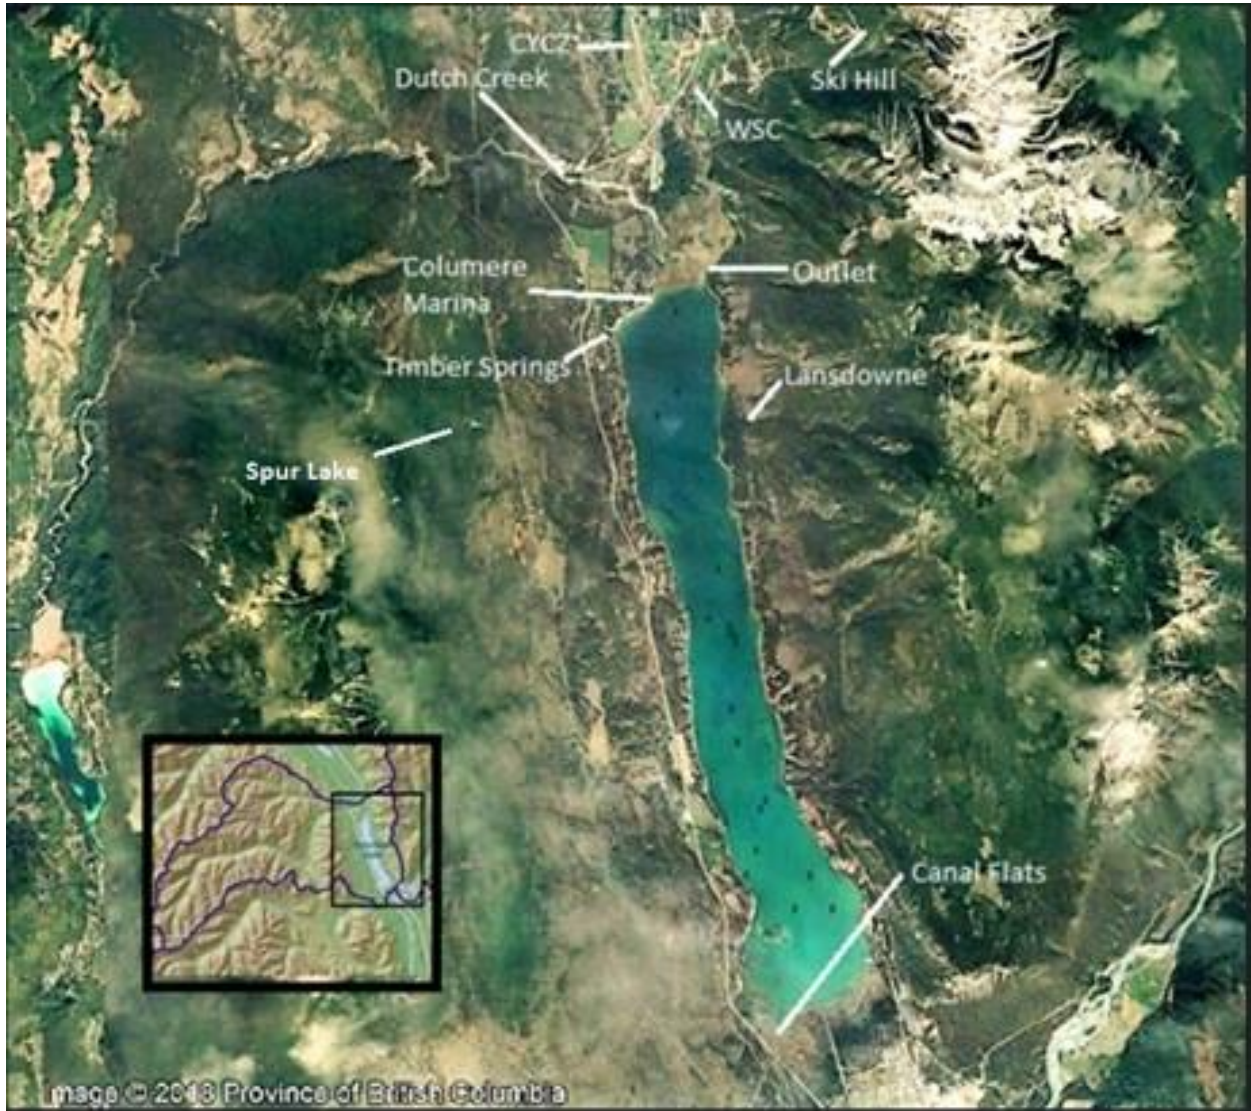
Figure 1 – Map showing station locations. Entire watershed boundary is shown in inset. Site abbreviations are provided in Section 4.1.

A series of small creeks enter the Columbia River downstream of the Dutch Creek junction and constitute about nine square kilometres of the entire 881 square kilometre area. The area above the usual lake outlet is 176 square kilometres. The boundaries of the watershed are shown in the inset of Figure 1.

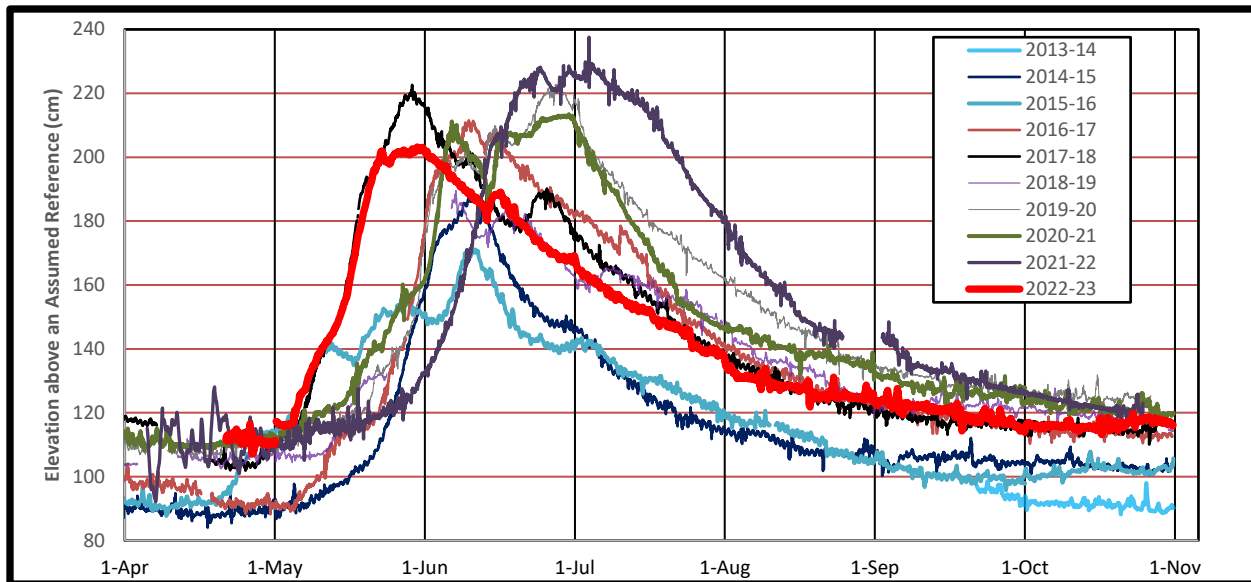
Figure 9 – 2023 Columbia Lake water levels compared with water levels recorded during the 2014 to 2022 open water seasons.

As a result of the abnormally warm spring, the 2023 lake water level graph shown in Figure 9 is skewed leftward when compared to those of the 2014 to 2022 seasons, inclusive, with one exception. The graph of 2018 is similar in terms of timing, rate of rise and crest date though not crest elevation. In both years the crest occurred 2-4 weeks earlier than in most previous seasons. The lake level was on track to recede faster than in most previous seasons, and would have done so, had runoff from a period of rain during mid-June not intervened.

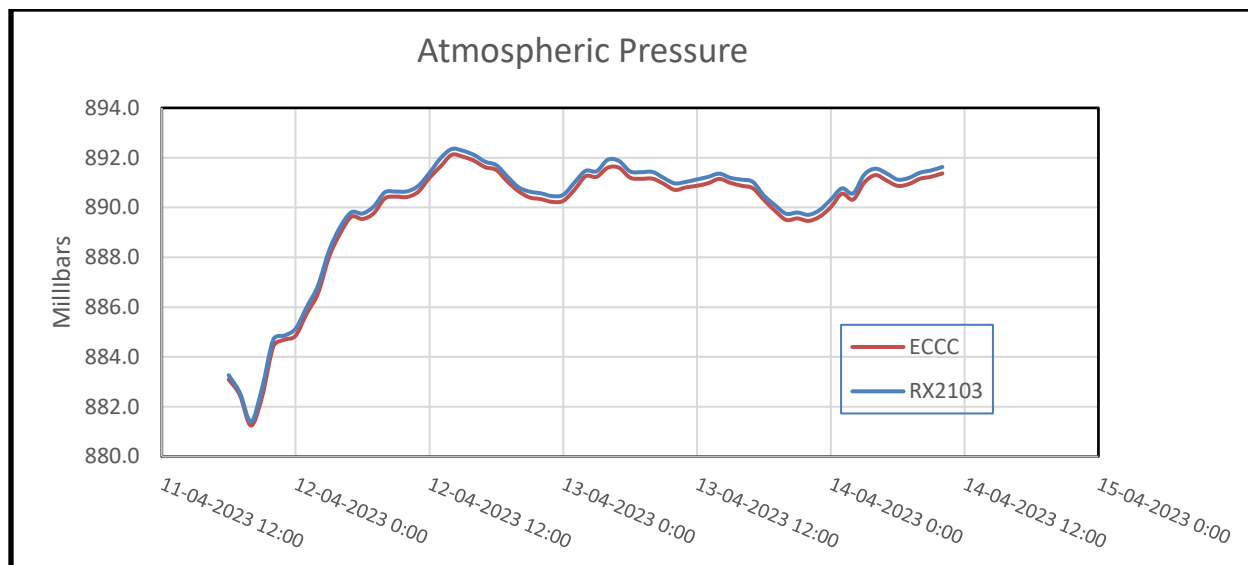
Figure A1 – Deviation of atmospheric pressure measured by barometric sensor on HOBOLink RX2103 from Environment and Climate Change Canada (ECCC) barometer. Deviation was 1.1 mb (1.12 cm of H2O)

During the summer of 2023 the management of Fairmont Hot Springs Airport (CYCZ) moved its decommissioned weather station to a new location, installed a new processor and put it back into operation. The new station does not record but altimeter settings can be obtained by phone. A routine was established to phone the station at periodic intervals, collect the altimeter setting and convert it to pressure in centimetres of water. The converted values now serve as a standard for evaluating the performance of the RX2103 barometer and thereby avoid the need to move equipment to the location of precision barometer in the future.

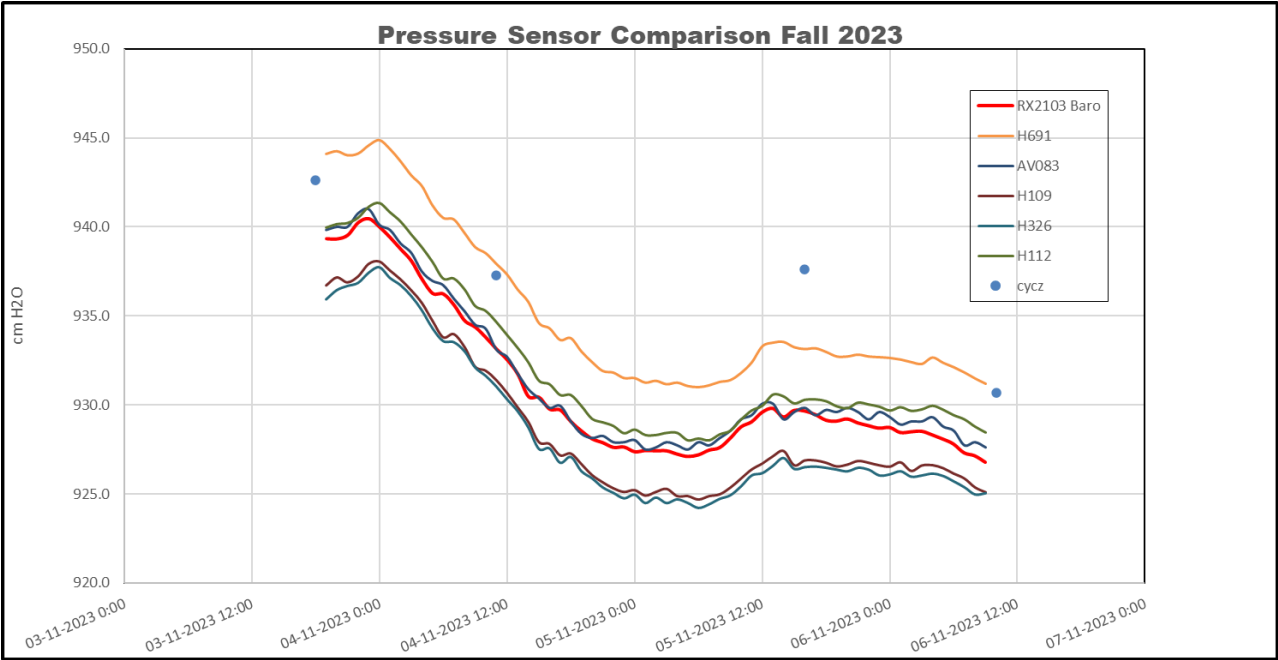
Figure A3 – Pressure readings from all loggers at end of water year. RX2103 was not collocated. It remained in operation at the Columere marina at a level about 40 metres below the collocated loggers. Its pressure was adjusted to the level of the test site by subtracting 5.5 cm H₂O. CYCZ is also located

near the lake level. The spot pressures shown have not been adjusted to correct for the elevation difference.

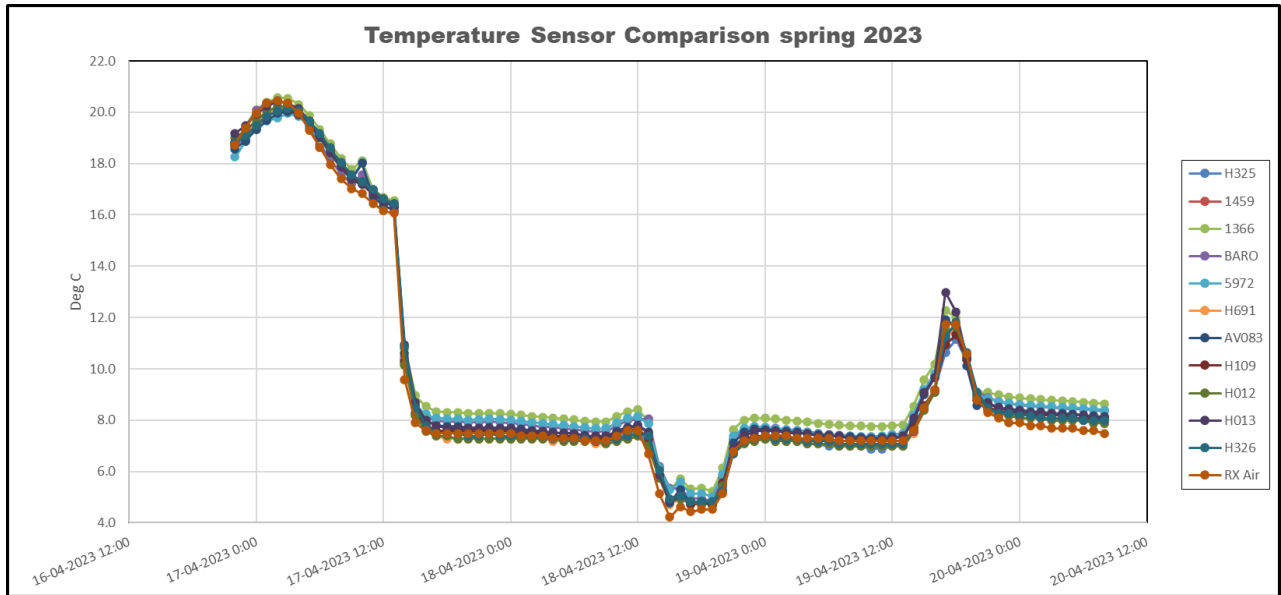
Figure A4 – Temperature readings in relation to H325 at midwater year.

Beginning and end-of-season comparisons of the temperature sensors were made in a similar fashion. The records are displayed in Figures A3 and A4, respectively. The exposure of the loggers to sunlight was not well controlled, especially during the Nov-23 run causing some to record slightly warmer temperatures than others. Otherwise, good agreement is shown.
