Summary of Columbia Lake Stewardship Society's 2023-24 Water Quantity Monitoring Program

Prepared by W. Thompson, M.Sc.

January 2025

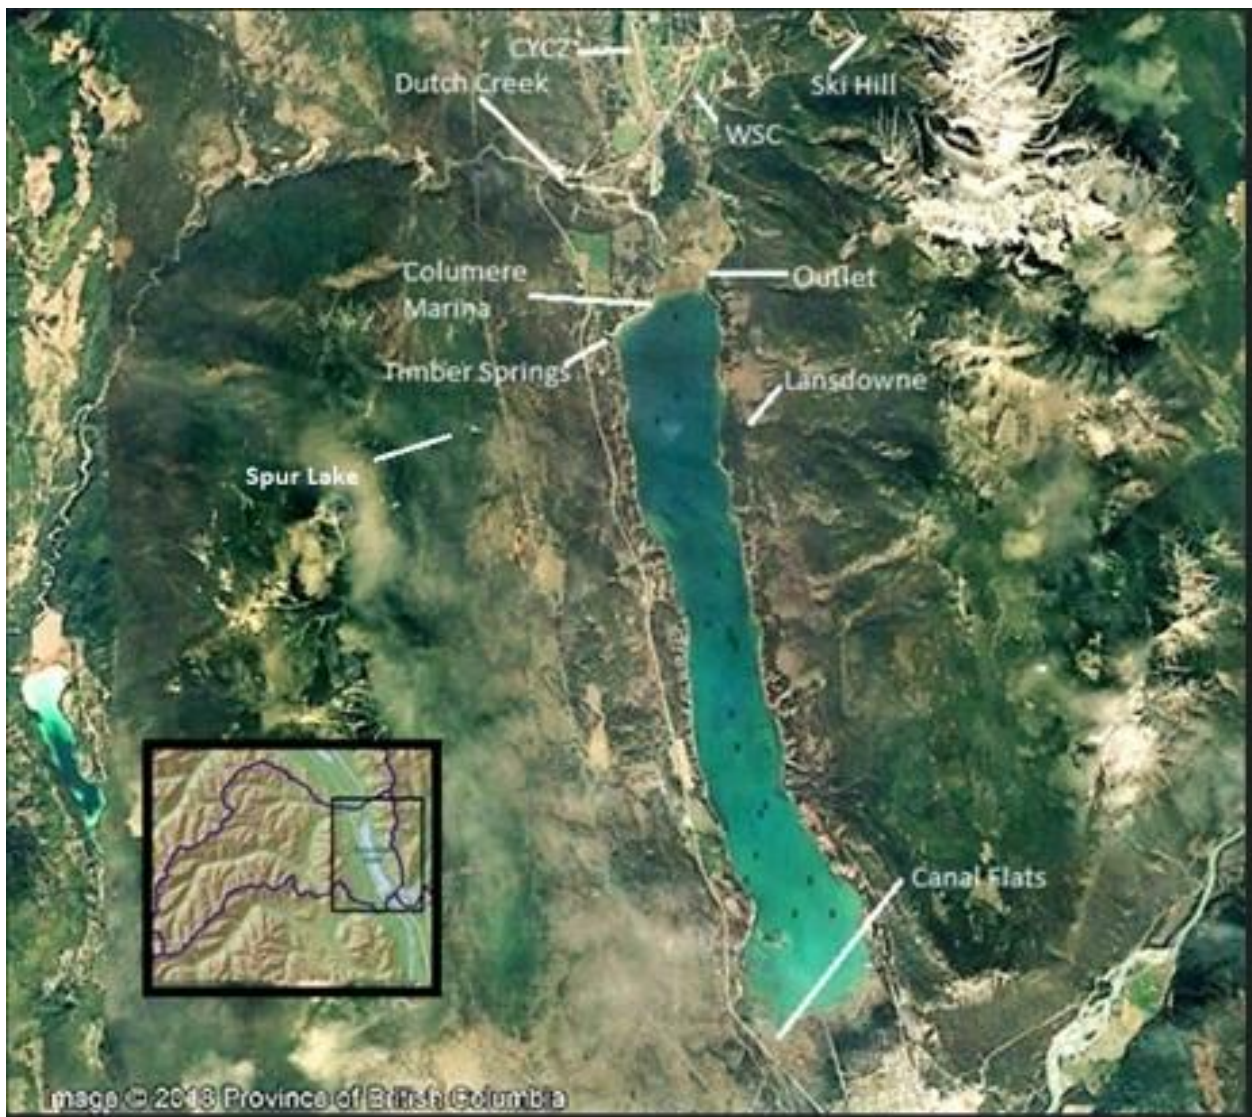
Figure 1 – Map showing station locations. The integrated watershed boundary is shown in the inset. Site abbreviations are provided in Section 4.1.

A series of small creeks enter the Columbia River downstream of the Dutch Creek junction constitute about nine square kilometres of the entire 881 square kilometre area. The area above the usual lake outlet is 176 square kilometres. The boundaries of the watershed are shown in the inset of Figure 1.

The water level monitoring stations in operation were: Columere Marina (COL), Columbia River near Fairmont Hot Springs (WSC), Dutch Creek at the Highway 93/95 Bridge (DC), and (Outlet) located near the lake outlet. The locations are shown in Figure 1. DC only operated during the open water season. COL measures lake level. Backup sensors were installed at the COL, WSC, and Outlet sites though not all remained operative for the entire year. A logger was installed for part of the season at WSC to measure atmospheric pressure to back up the RX2103 atmospheric pressure sensor.

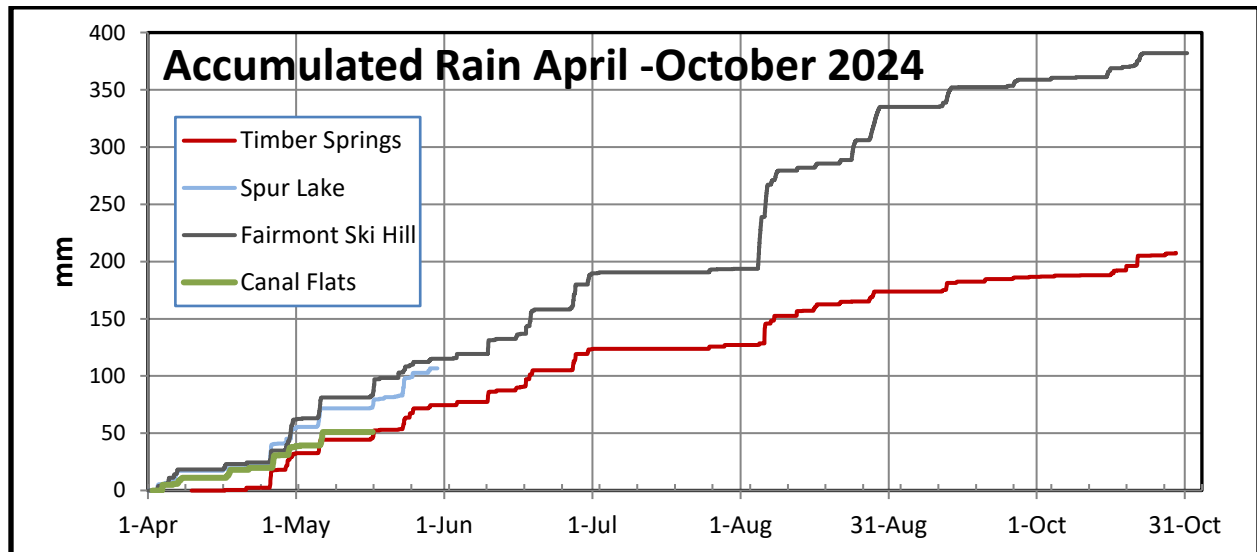
Figure 4 – Accumulated precipitation measured at Timber Springs (elevation 850 m asl), Spur Lake (1175), Fairmont Ski Hill (1480) and Canal Flats (820) during 2024.

Available accumulated rainfall amounts at the Timber Springs and Fairmont Ski Hill weather stations, and the Spur Lake and Canal Flats rain gauges, are shown in Figure 4. Both the Canal Flats and the Spur Lake stations stopped operating during May for reasons that will be noted. Southeastern BC was again subjected to forest fires in 2024 though none of significance was reported in the watershed. This may have been in part due to variations in the regional rainfall pattern. The Cranbrook Airport, for example, recorded only 65.4 mm over the same seven-month period.

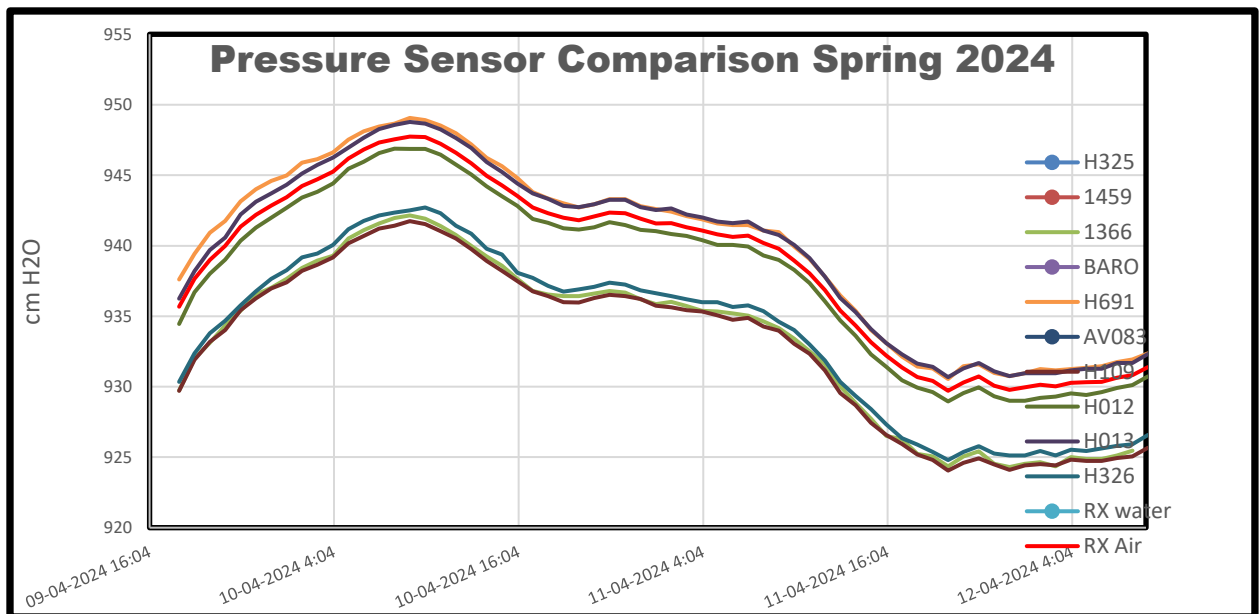
Figure A3 – Pressure readings from all loggers Spring 2024. Loggers were co-located.
