Summary of Columbia Lake Stewardship Society's 2015 Monitoring Program

Prepared by W. Thompson
January, 2016

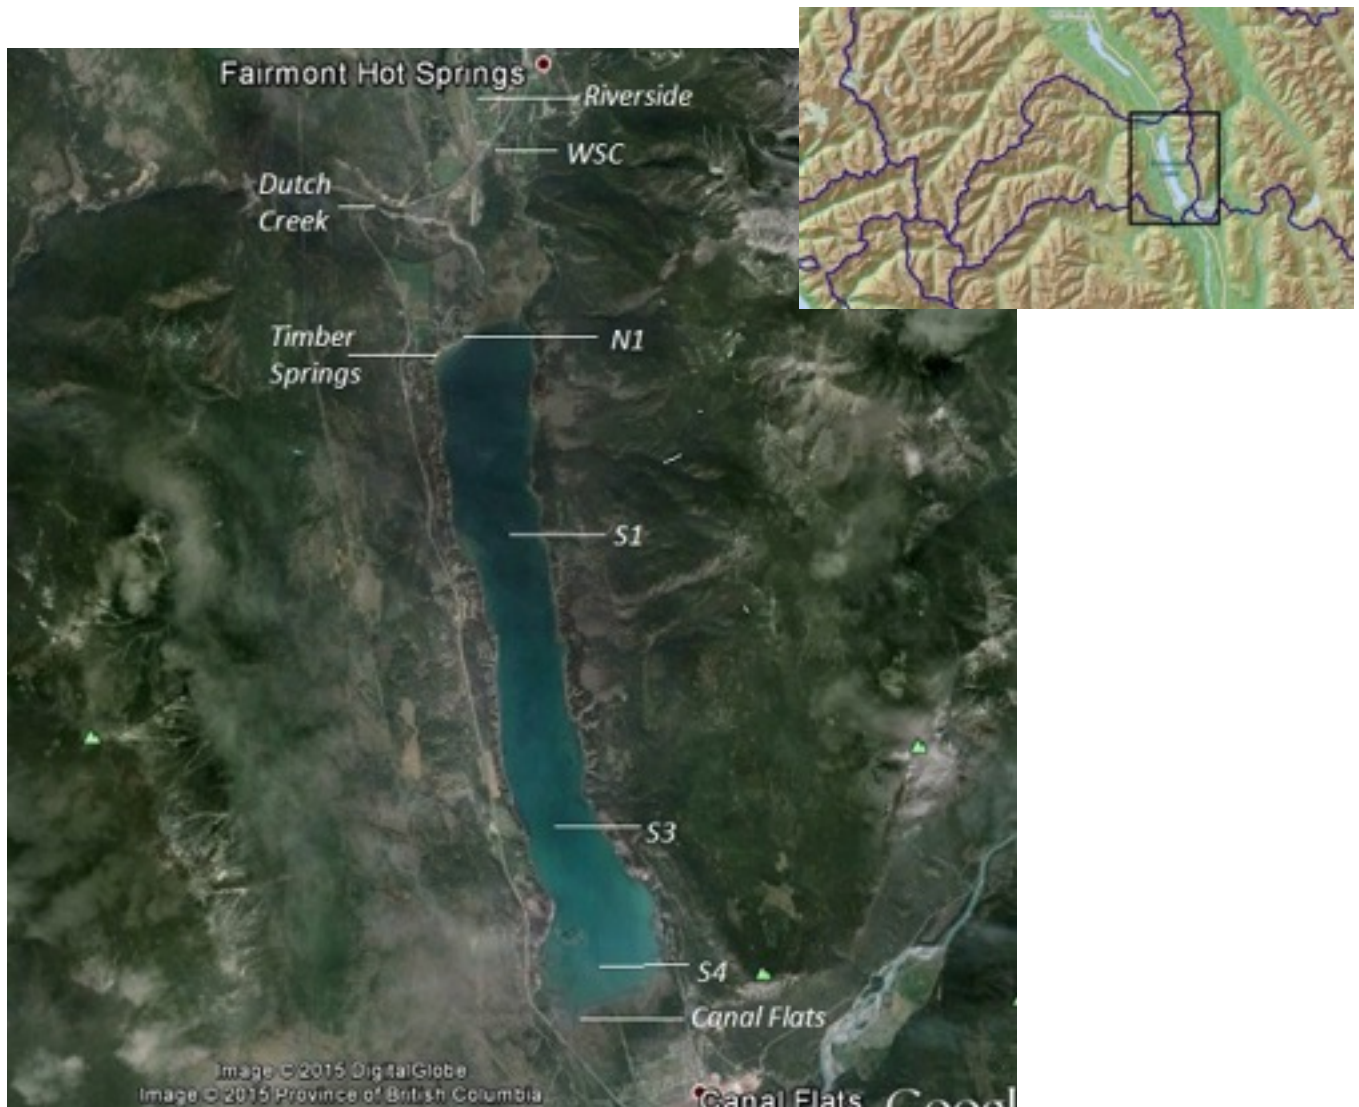
Figure 3 - Locations of Water Quality sites (N1, S1, S3 and S4) and Water Quantity monitoring sites used in 2015. Watershed boundary is shown in inset.

The drainage area of the Columbia Lake Watershed above the Highway 93/95 crossing near Fairmont Hot Springs is 881 square kilometres. The bulk, 696 square kilometres, is contained in the Dutch Creek sub-basin. Not all of the water from Dutch Creek enters the Lake, some by-passes to the north and flows directly into the Columbia River. The proportion flowing into the Lake has varied over the years due to shifting drainage channels in the Creek delta. The boundaries of the Watershed are shown in the inset of Figure 3.

The locations of the Water Quality and Water Quantity monitoring sites are shown in Figure 3.

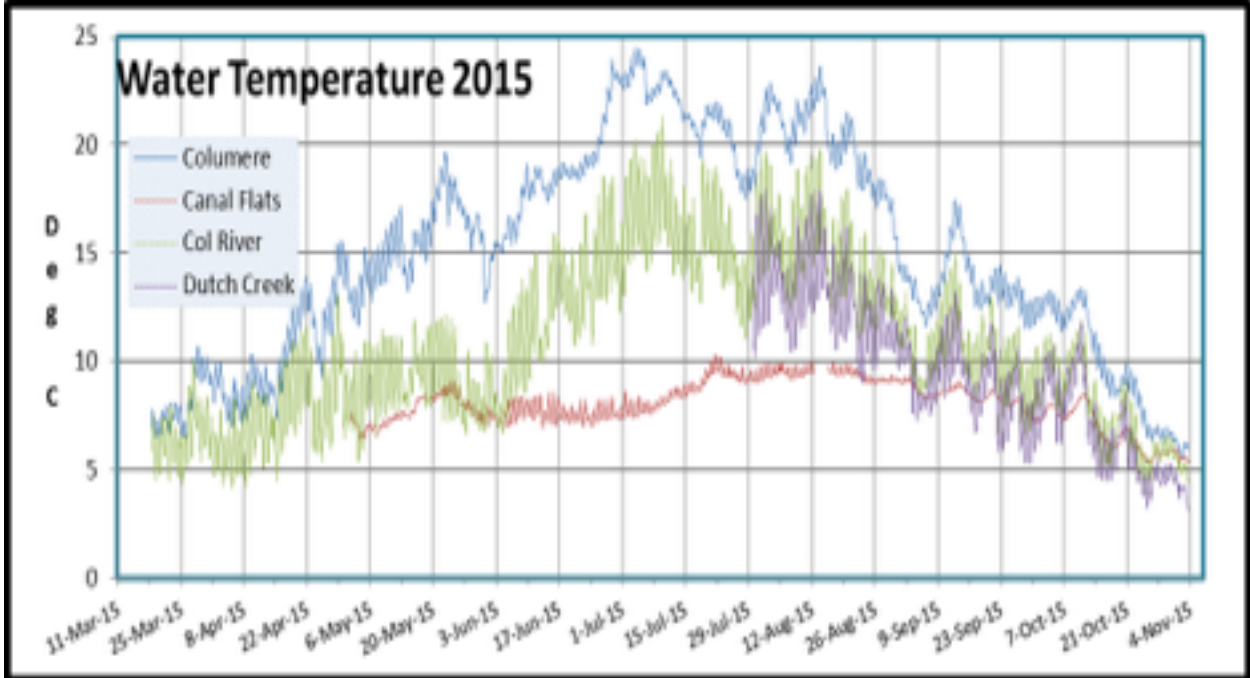
Figure 4 - Water temperatures recorded at the inflow, outflow and Lake monitoring points.

The water temperatures recorded at the four water level stations are shown in Figure 4. Temperatures recorded in the Lake were consistently warmer than those recorded in the inflowing and outflowing waters. Much cooler temperatures were recorded from about June 1 to August 31 in the unnamed creek flowing into Columbia Lake in the Headwaters Park near Canal Flats. The source of that stream is groundwater and the temperatures are reflective of January 28, 2016

that origin. The temperatures at all sites displayed diurnal variation with significant day to night differences apparent in the Dutch Creek and Columere records.

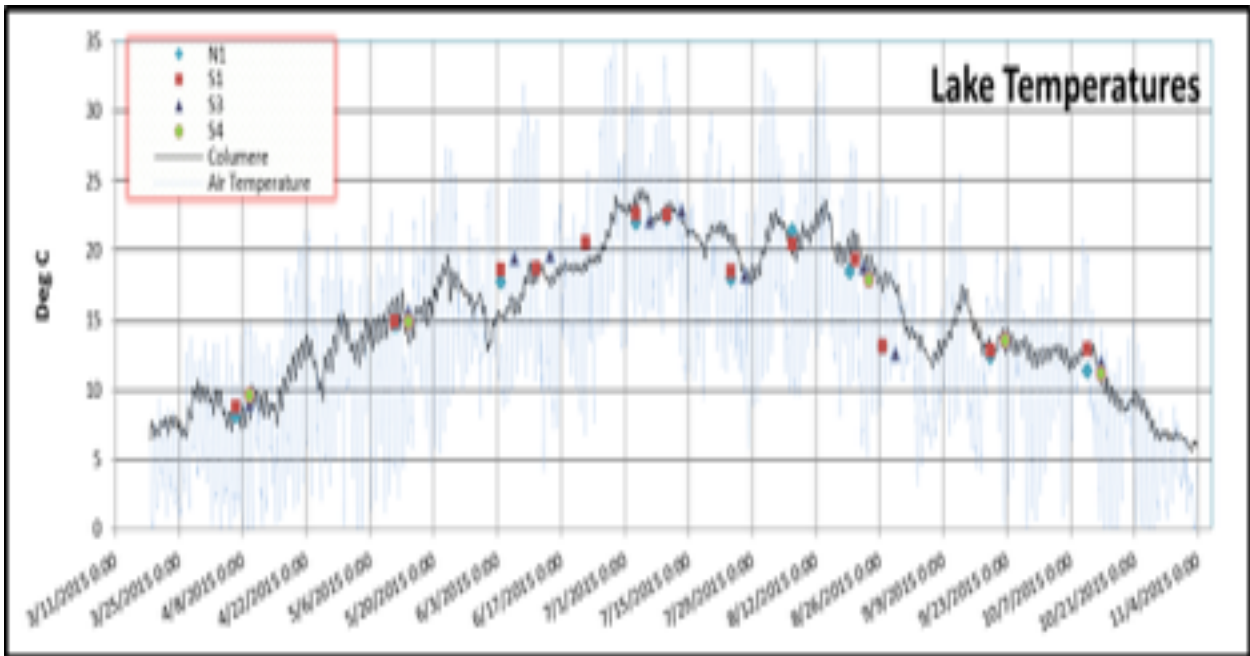
Figure 5 - Comparison of surface water temperatures at Lake sampling sites with water temperature recorded at the Columere Marina. Air temperature recorded at Timber Springs appears in the background.

The extent to which the temperatures recorded in the Columere Marina represent those in the Lake is of some interest because the Marina is surrounded by a breakwater that restricts water circulation. The issue is addressed in Figure 5 by comparing the surface water temperatures recorded at each of the four Lake sampling sites with those recorded in the Marina. Although there were some noticeable differences, there was fairly good agreement overall suggesting that the Marina temperatures are a reasonable reflection of temperatures within the overall Lake. The sensor at the Columere Marina is mounted about 70 cm above the Lake bed and 75 to 175 cm below the surface depending on month.

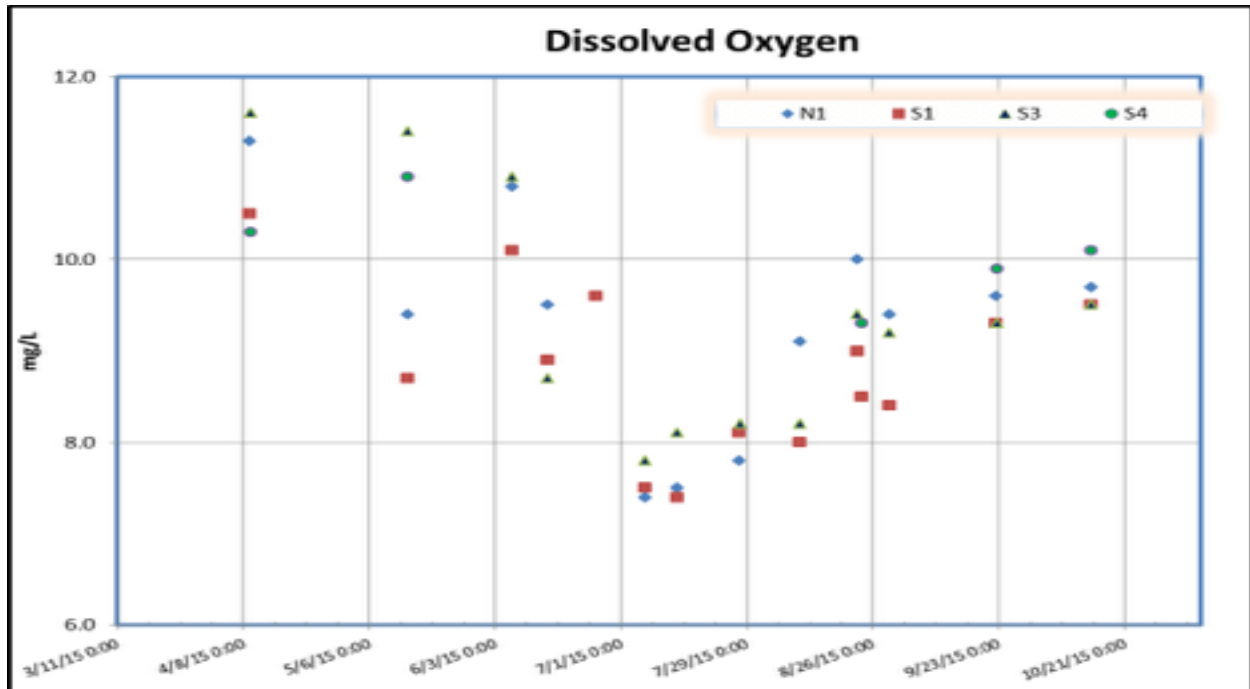
Figure 6 - Levels of dissolved oxygen made at the 0.5 depth level. Levels were lowest during the warm water period in accordance with expectation.

The observed measures of dissolved oxygen at the upper level are shown in Figure 6.

Normally the level of dissolved oxygen is higher in cool water and lower in warm water so that the decline shown during mid-season is to be expected.

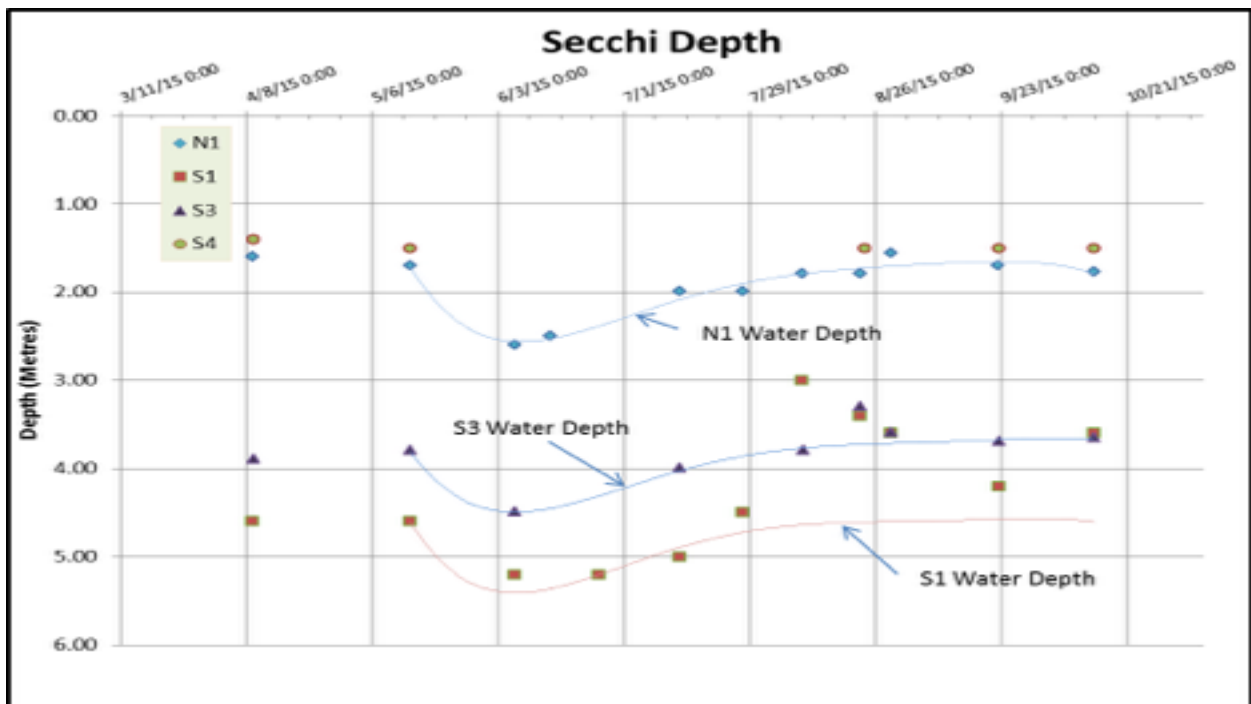
Figure 10 - Secchi Plate depths. Solid lines depict water depths during the May 14 to Oct 13 period and are derived from measured values.

Water clarity can also be measured by observing the depth at which a Secchi Disc (a black and white plate) disappears from view when submerged. The greater the depth, the greater the clarity. A survey conducted by BC Lake Stewardship Society (2014) revealed that the median “Secchi” depth for BC Lakes is in excess of 4 metres so that the procedure is not particularly applicable to Columbia Lake where the maximum depth is only 5.3 metres at high water. Nevertheless it can be seen in Figure 10 that the “Secchi” depths started to become less than the water depths at S1 during late July and persisted until the end of the season with greatest differences in August. The differences were not so noticeable at S3.

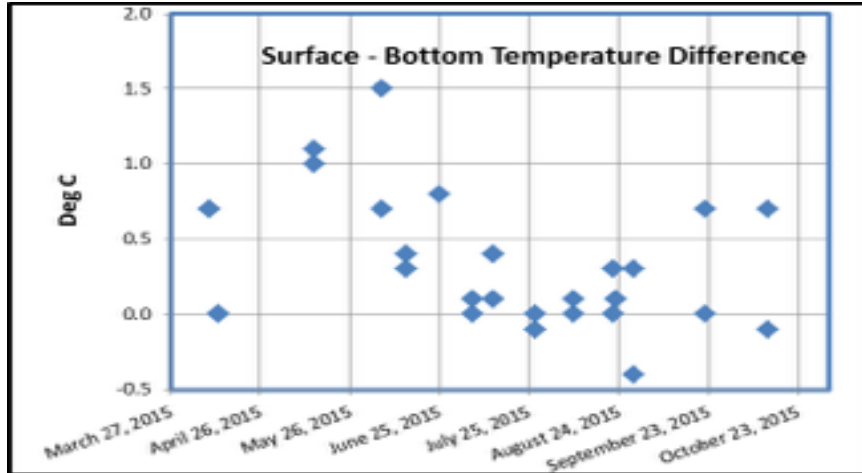
Figure 12 - Difference in water temperature between surface and Lake bed at Sites S1 and S3.

Figures 12 to 14 display the difference in values of selected parameters between the surface and the Lake bed at the two deep water locations, S1 and S3. Figure 12 shows that the temperatures near the bottom of the Lake were less than 0.5 Deg C of those at the surface during July, August and early September. A tendency to higher values existed outside that period. Negative differences are unsustainable. Ignoring outliers Figure 13 indicates that surface levels of Conductivity tended to be greater than those at depth early in the season but the difference disappeared by about August 1. Again ignoring outliers Figure 14 shows that the levels of Dissolved Oxygen at depth were mainly within the range of 0 to 0.5 mg/L above those near the surface and the difference was consistent over the course of the season.

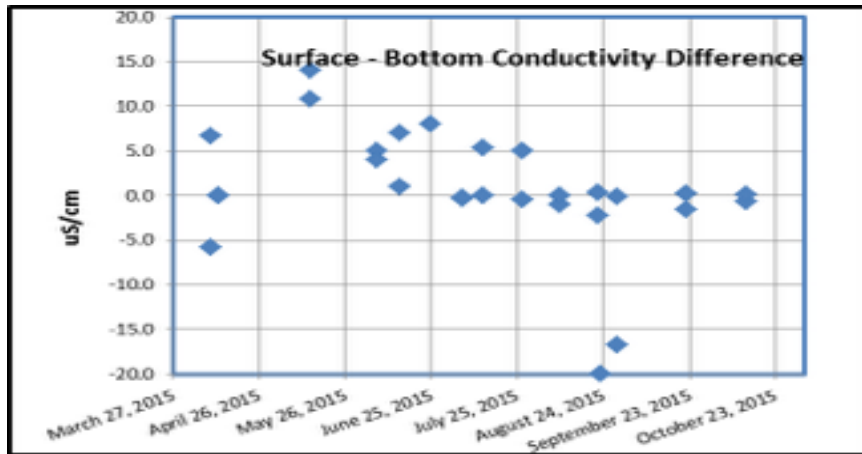
Figure 13 - Difference in Conductivity values between Lake surface and Lake bed at Sites S1 and S3.

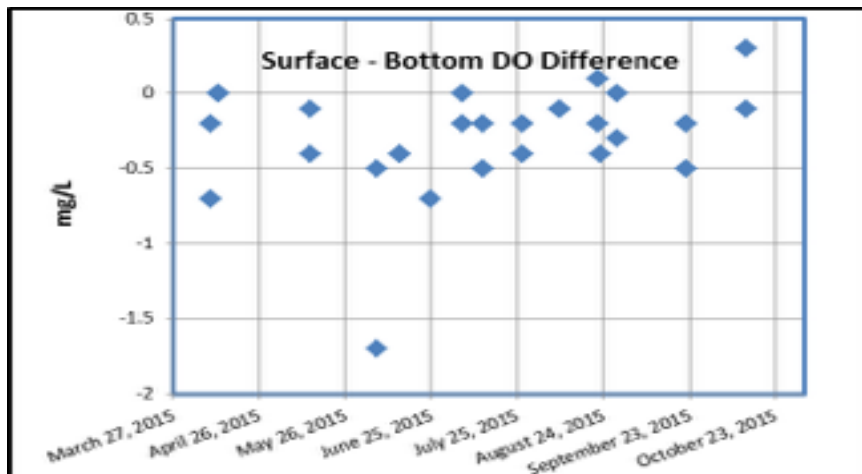
Figure 14 - Difference in Dissolved Oxygen values between a level 0.5 metres below the Lake surface and a level 0.5 above the Lake bed at Sites S1 and S3.

The difference between the level of DO at the upper level and lower level are shown in Figure 14. For the most part the levels of DO at the upper level were between 0 and 0.5 mg/l less than those at the lower level.

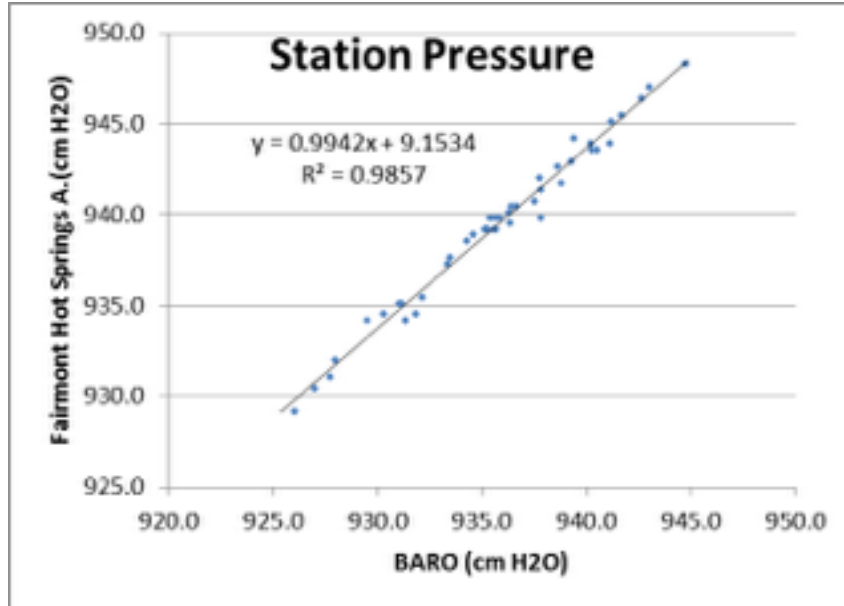
Figure 1 - Comparison of atmospheric pressure measurements made by the BARO located in the Timber Springs community with those at the Fairmont Hot Springs Airport.

The Fairmont Hot Springs Airport operates a weather station for aviation purposes. That station is equipped with two barometers. At five second intervals a reading from each barometer is taken, the readings averaged, the average converted to an altimeter setting and the setting broadcast to approaching aircraft. Forty six of these messages were intercepted during the May 4 -28, 2015 period. The altimeter setting was abstracted and converted to atmospheric pressure. The resulting values were correlated with concurrent pressure measurements made by the BARO capsule located in the Timber Springs Community approximately 4 km distant and 40 metres higher in elevation. The results (see Figure 1) showed that the BARO would be an acceptable standard and further that it could be used to compensate the readings from the submerged capsules for atmospheric pressure by applying the algorithm $y=0.09942x + 9.1534$ where y is the atmospheric pressure at Lake level and x is the BARO reading.

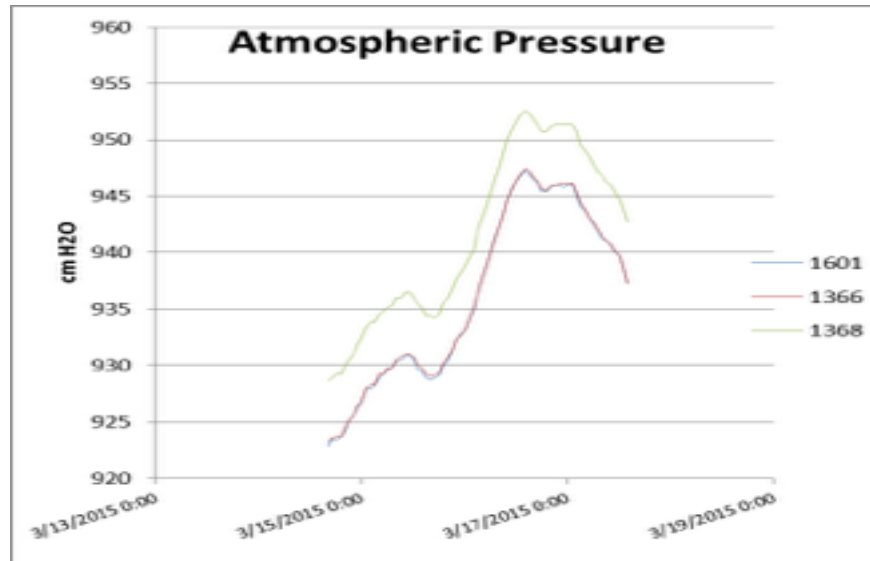
Figure 2 - Comparison of atmospheric pressure measurements at the beginning of the season made by Capsules 1366 (Riverside), 1368 (Columere Marina) and BARO (1601). All were mounted together at a location in the Timber Springs Community.

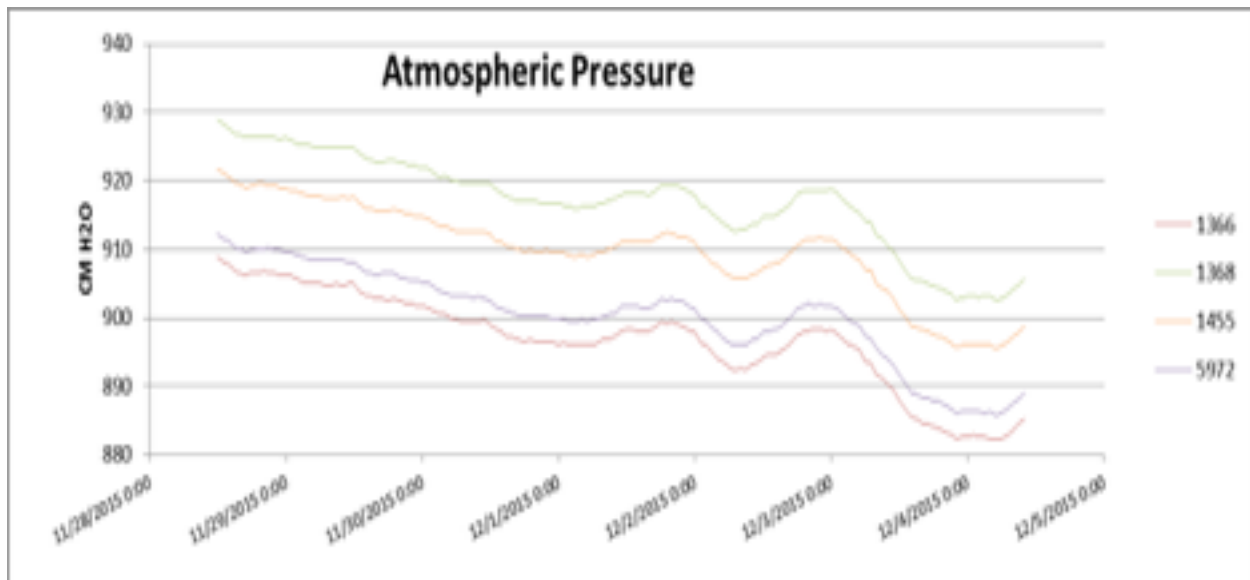
Figure 3 - Comparison of atmospheric pressure measurements made at the end of the season by Capsules 1366 (Riverside), 1368 (Columere Marina), 1455 (Dutch Creek) and 5972(a new capsule).

Capsule 1455 (Dutch Creek) also displayed a significant departure from capsule 1366 at the end of the season. Other comparisons indicate that the difference remained constant throughout the season.
